USE OF PRECAST-PRESTRESSED CONCRETE FOR BRIDGE DECKS

July 30, 1975
Revised Dec. 1976
Project: C-36-56N
File: 7-4-14

Joint Highway Research Project

Project No.: C-36-56N

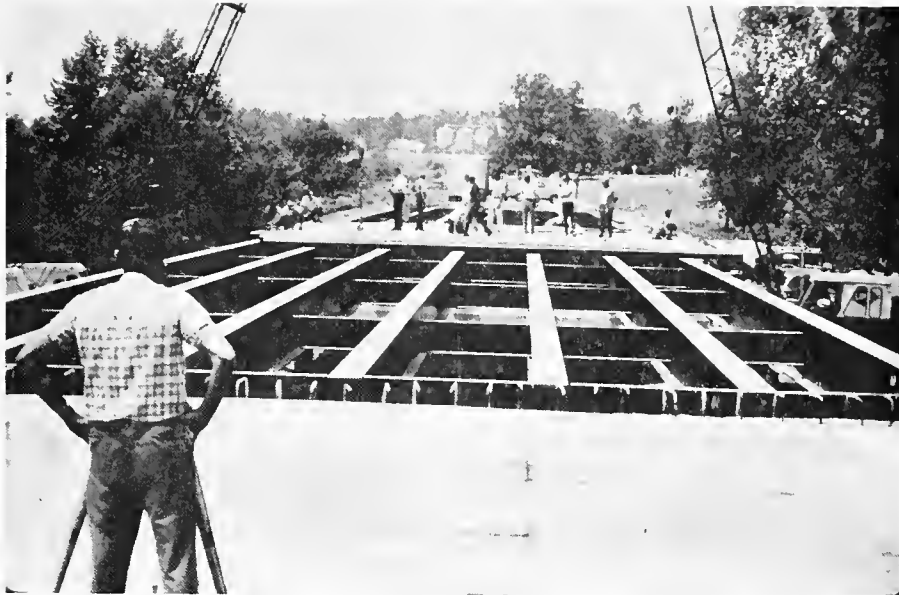
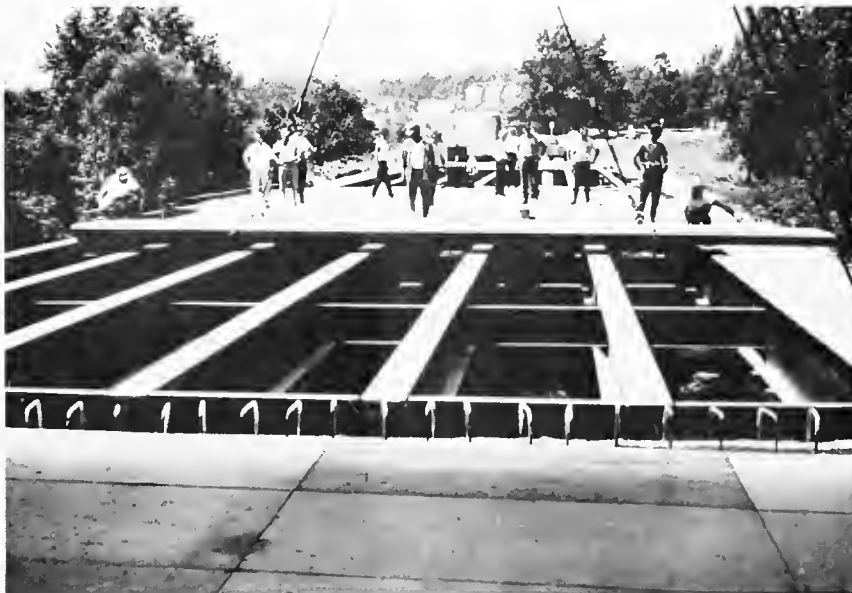
Figure #7. Precast Slab Placement at the Knightstown Bridge

were set and post-tensioned. Figure #7 shows the slab placement operation. A problem which arose during the post-tensioning operation was the appearance of eight 2'-0" long cracks which ran in the longitudinal direction of the bridge. This was due to irregularities in the top portions of the joints which caused a poor fit between adjacent units. The post-tensioning operation caused a bending stress in the slabs which fit poorly, resulting in the cracks. Due to the fact that water could seep down into these cracks and rust the pretensioning cables, a seal coat of epoxy was applied to the bridge. Integral curbs were poured in place on the bridge deck and the bridge was opened to traffic on August 6, 1970.

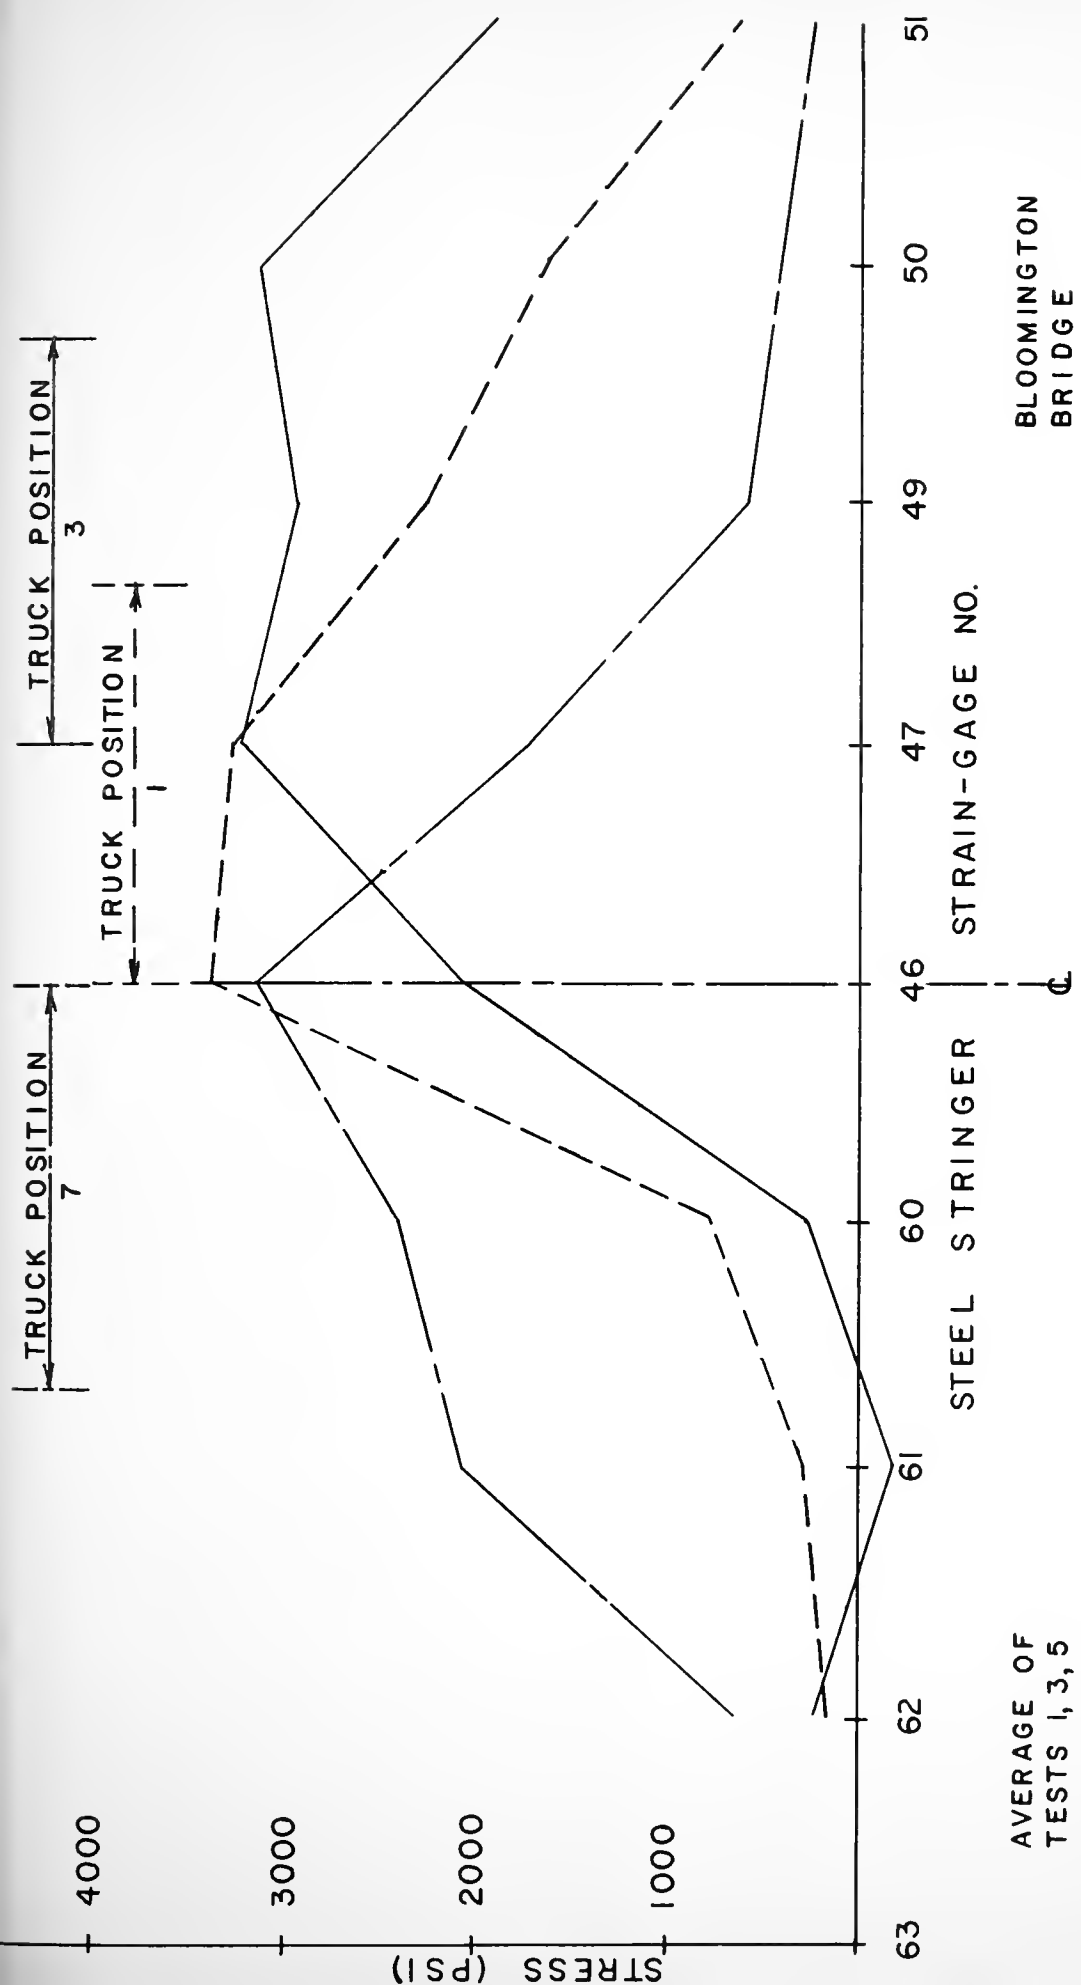
FIGURE NO. 19
DISTRIBUTION OF STRESSES AT SECTION W
FOR TRUCK POSITIONS 1, 3, AND 7.

Figure #19 indicates that the maximum stresses or moments occur in the stringers directly under the tandem axle, which was to be expected. (For truck positions #1, #3, and #7 the tandem axle of the test vehicle is centered directly over Section W. (See Figure #16). Figure #20 shows that as the test vehicle is moved away from the centerline of the stringers (i.e. Section W), the stresses at Section W decrease which also was to be expected.

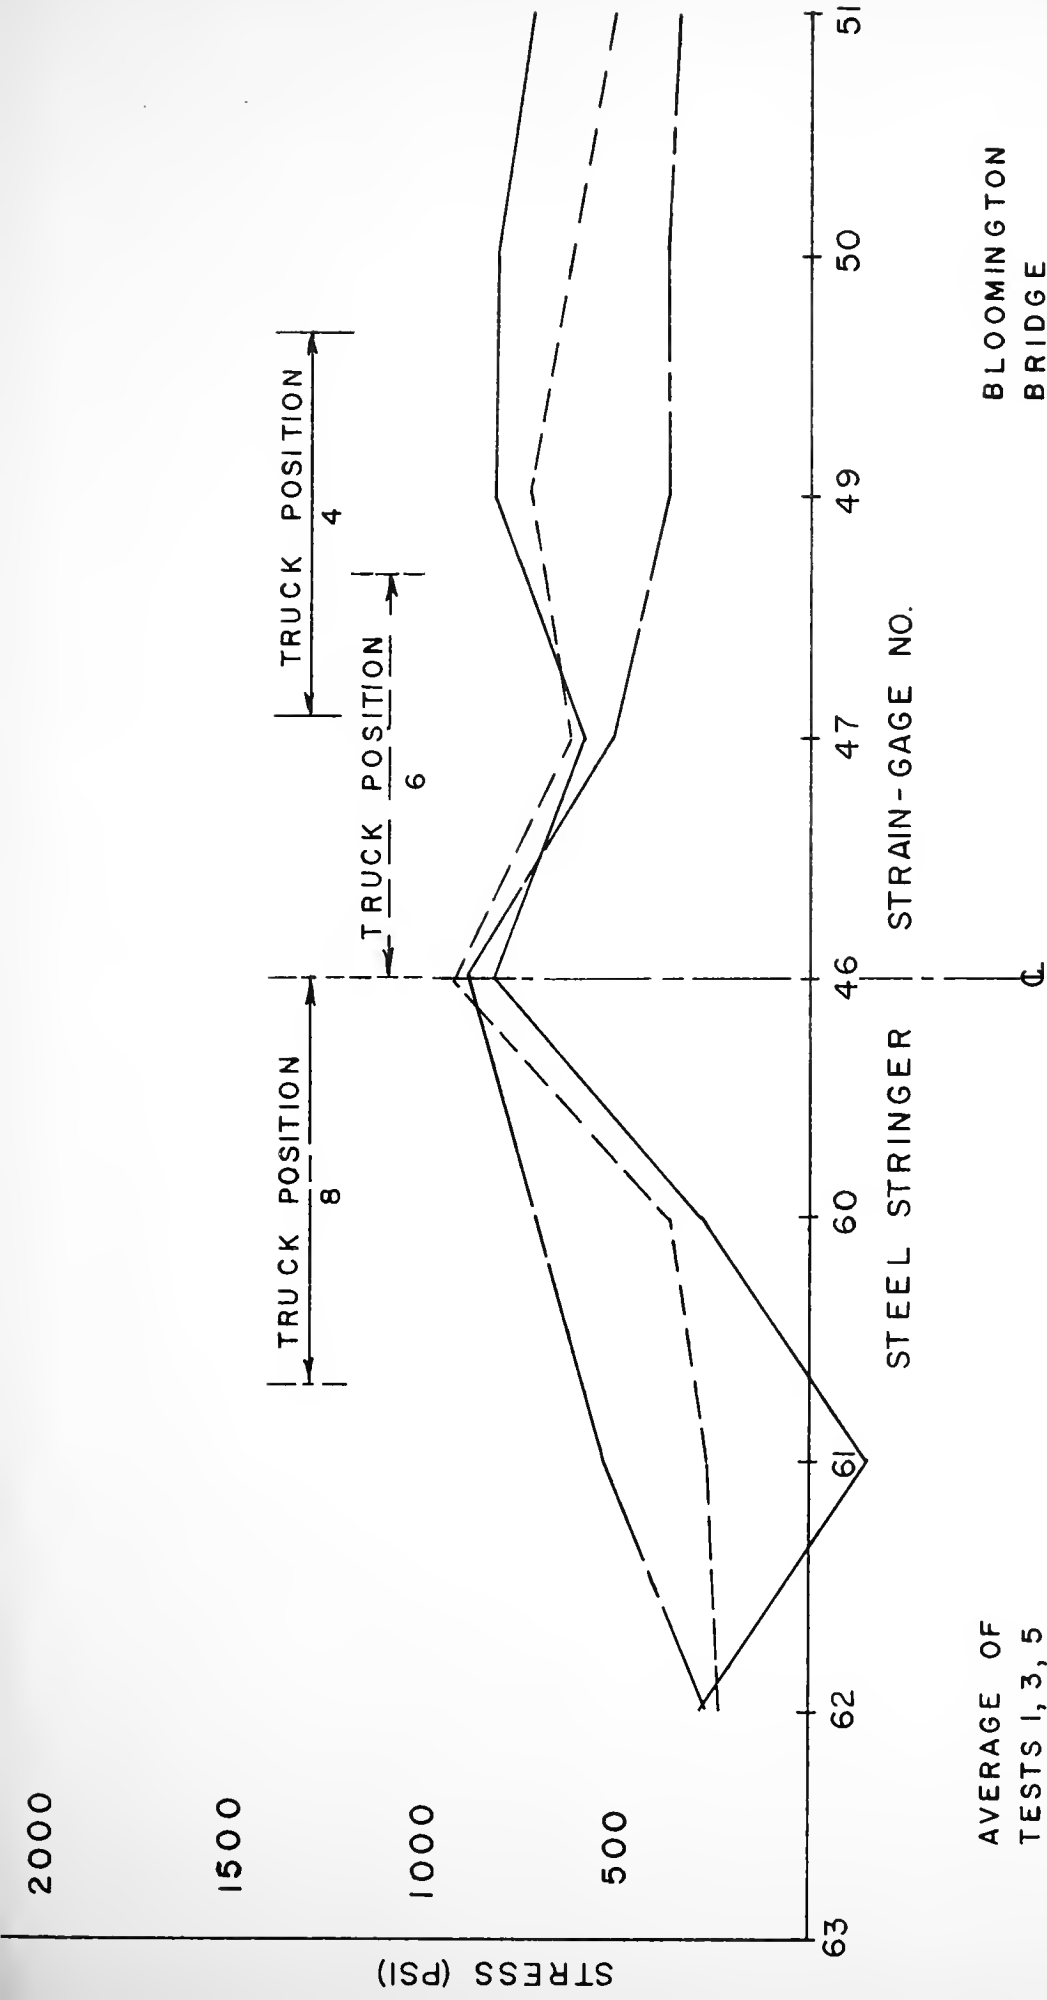
FIGURE NO. 20

DISTRIBUTION OF STRESSES AT SECTION W
FOR TRUCK POSITIONS 4, 6, AND 8.

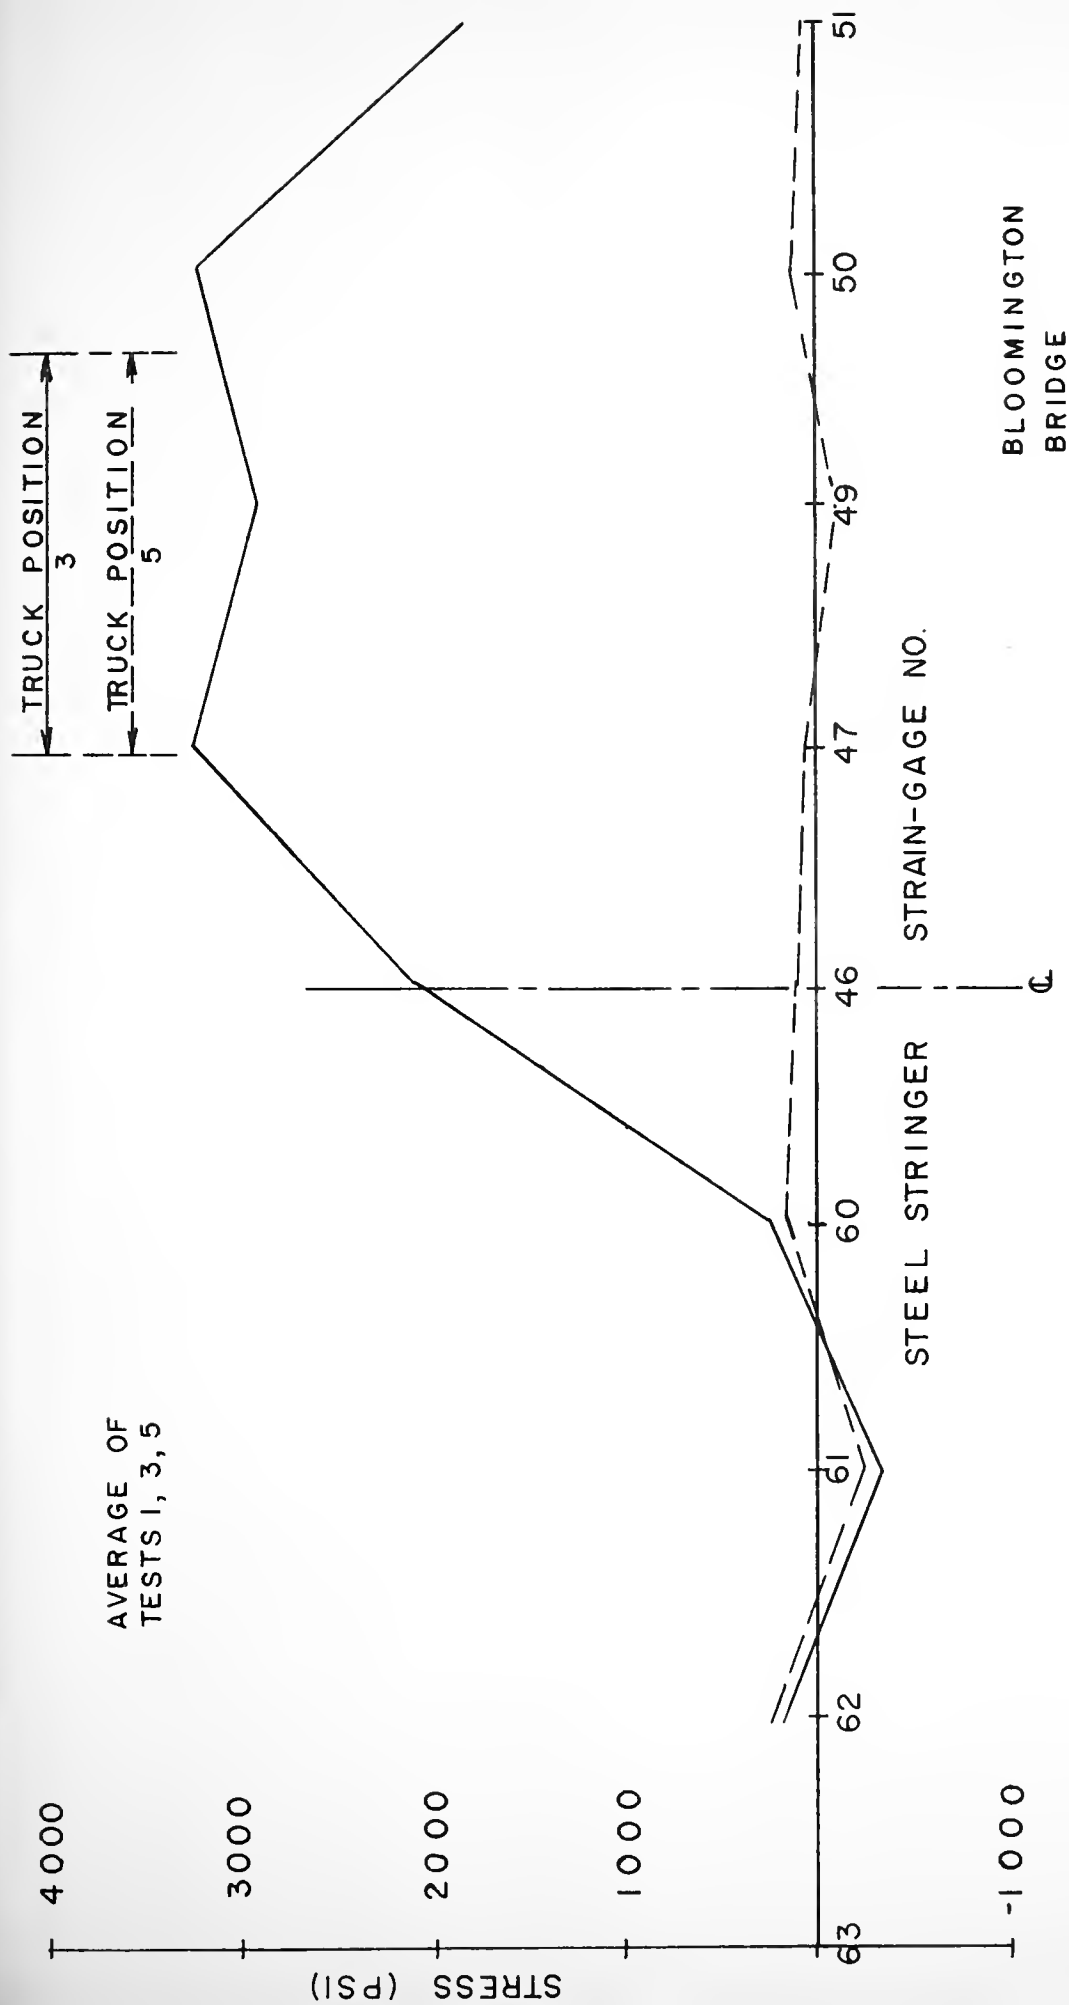
FIGURE NO. 21
DISTRIBUTION OF STRESSES AT SECTION W
FOR TRUCK POSITIONS 3 AND 5.

Figure #21 is included to show the magnitude of the load transmitted across the floor beam by the slabs. Referring to Figure #16 it can be seen that truck position #3 is midway between the first two floor beams while truck position #5 is midway between the second and third floor beams. Figure #21 indicates that very little moment is transferred across the floor beams. This would justify disregarding the front wheel loads in the calculation of the moment under the tandem axle, provided the front and tandem axles were not located between the same two floor beams. This would also indicate that for the purposes of design, the stringers could be assumed as simply supported at their support points.

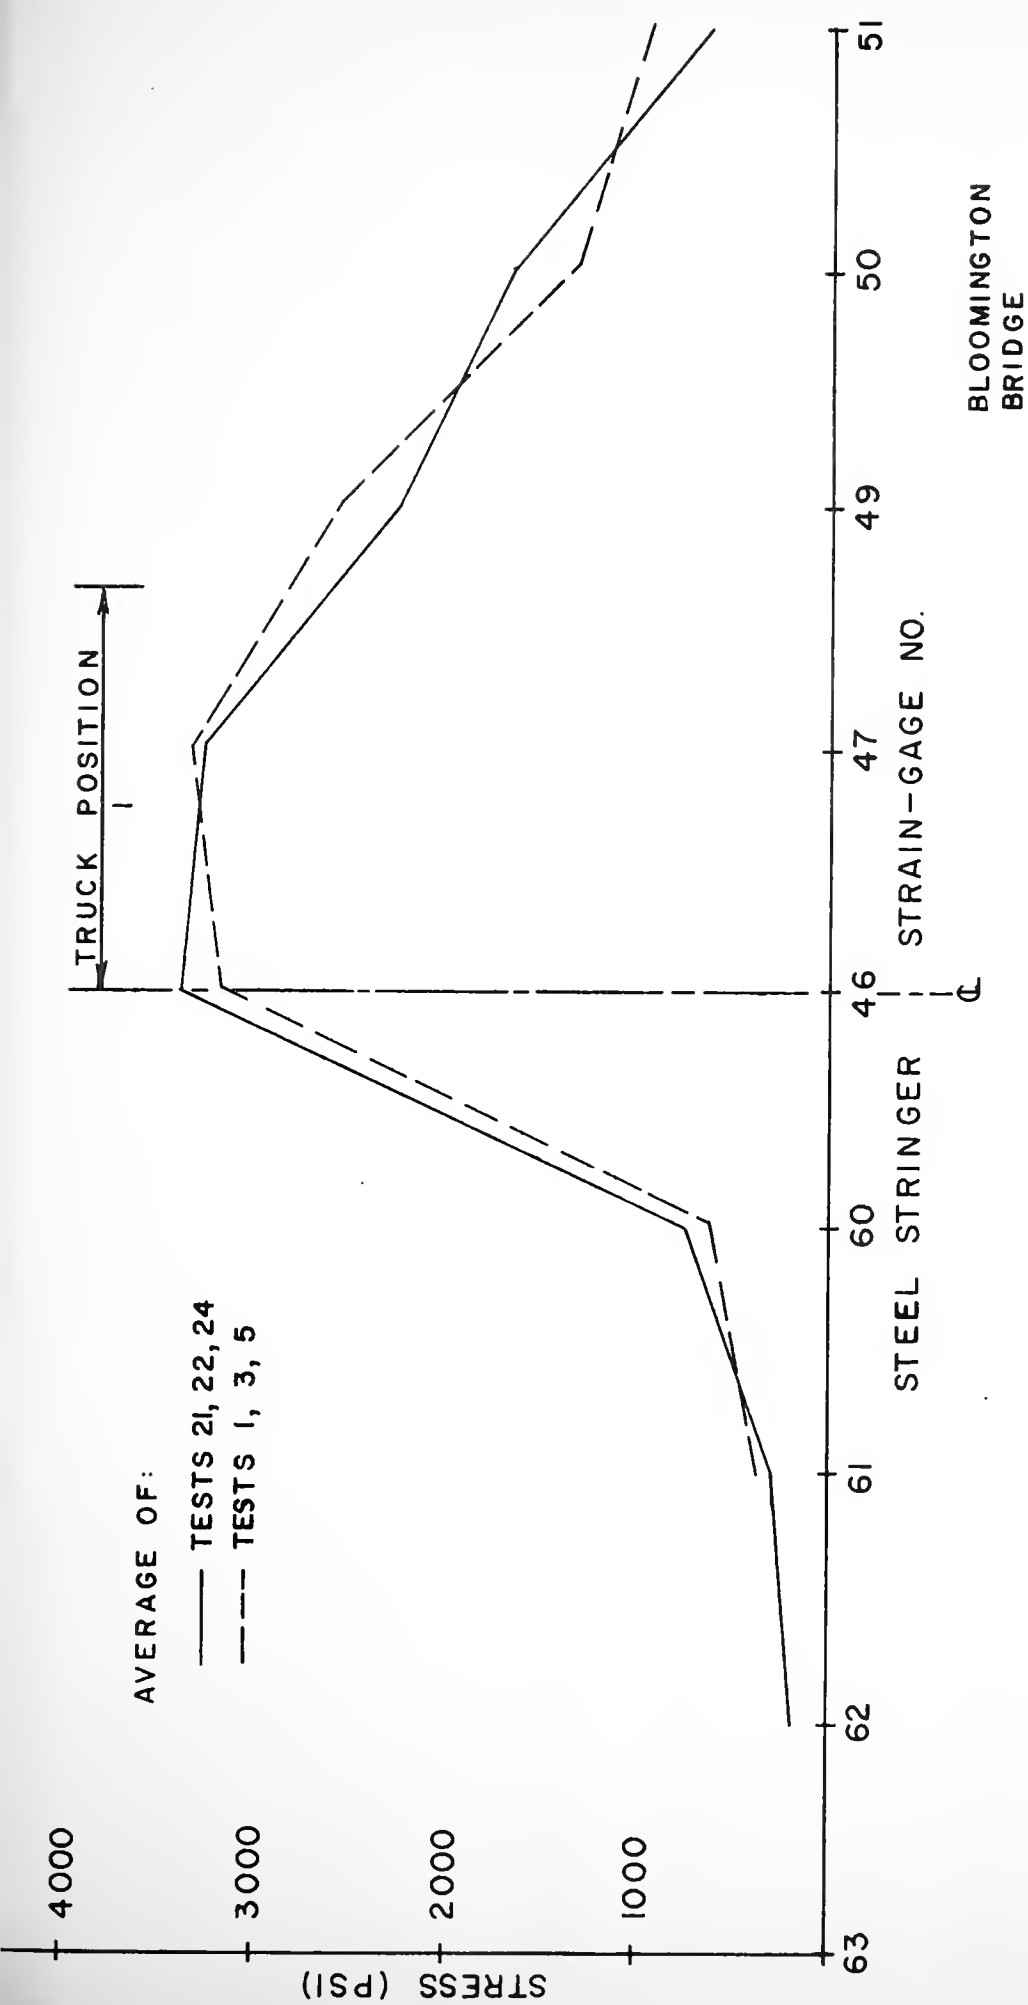
FIGURE NO. 22

In a previous section the variation of stress over a period of time for a particular gage was examined. Figures #22 and #23 indicate the change in the stress (load) distribution at Section W over a period of approximately two years. The stresses were averaged from Tests #1, 3, 5, and Tests #21, 22, 24 (See Tables B1, B2 and B3). The average of Tests #21, 22, 24 is plotted as a solid line. As was concluded for the stress variations over time for the individual strain gages, the load distribution has remained virtually unchanged over the two year time period.

TIME EFFECT ON THE DISTRIBUTION OF STRESS FOR TRUCK POSITION I AT SECTION W

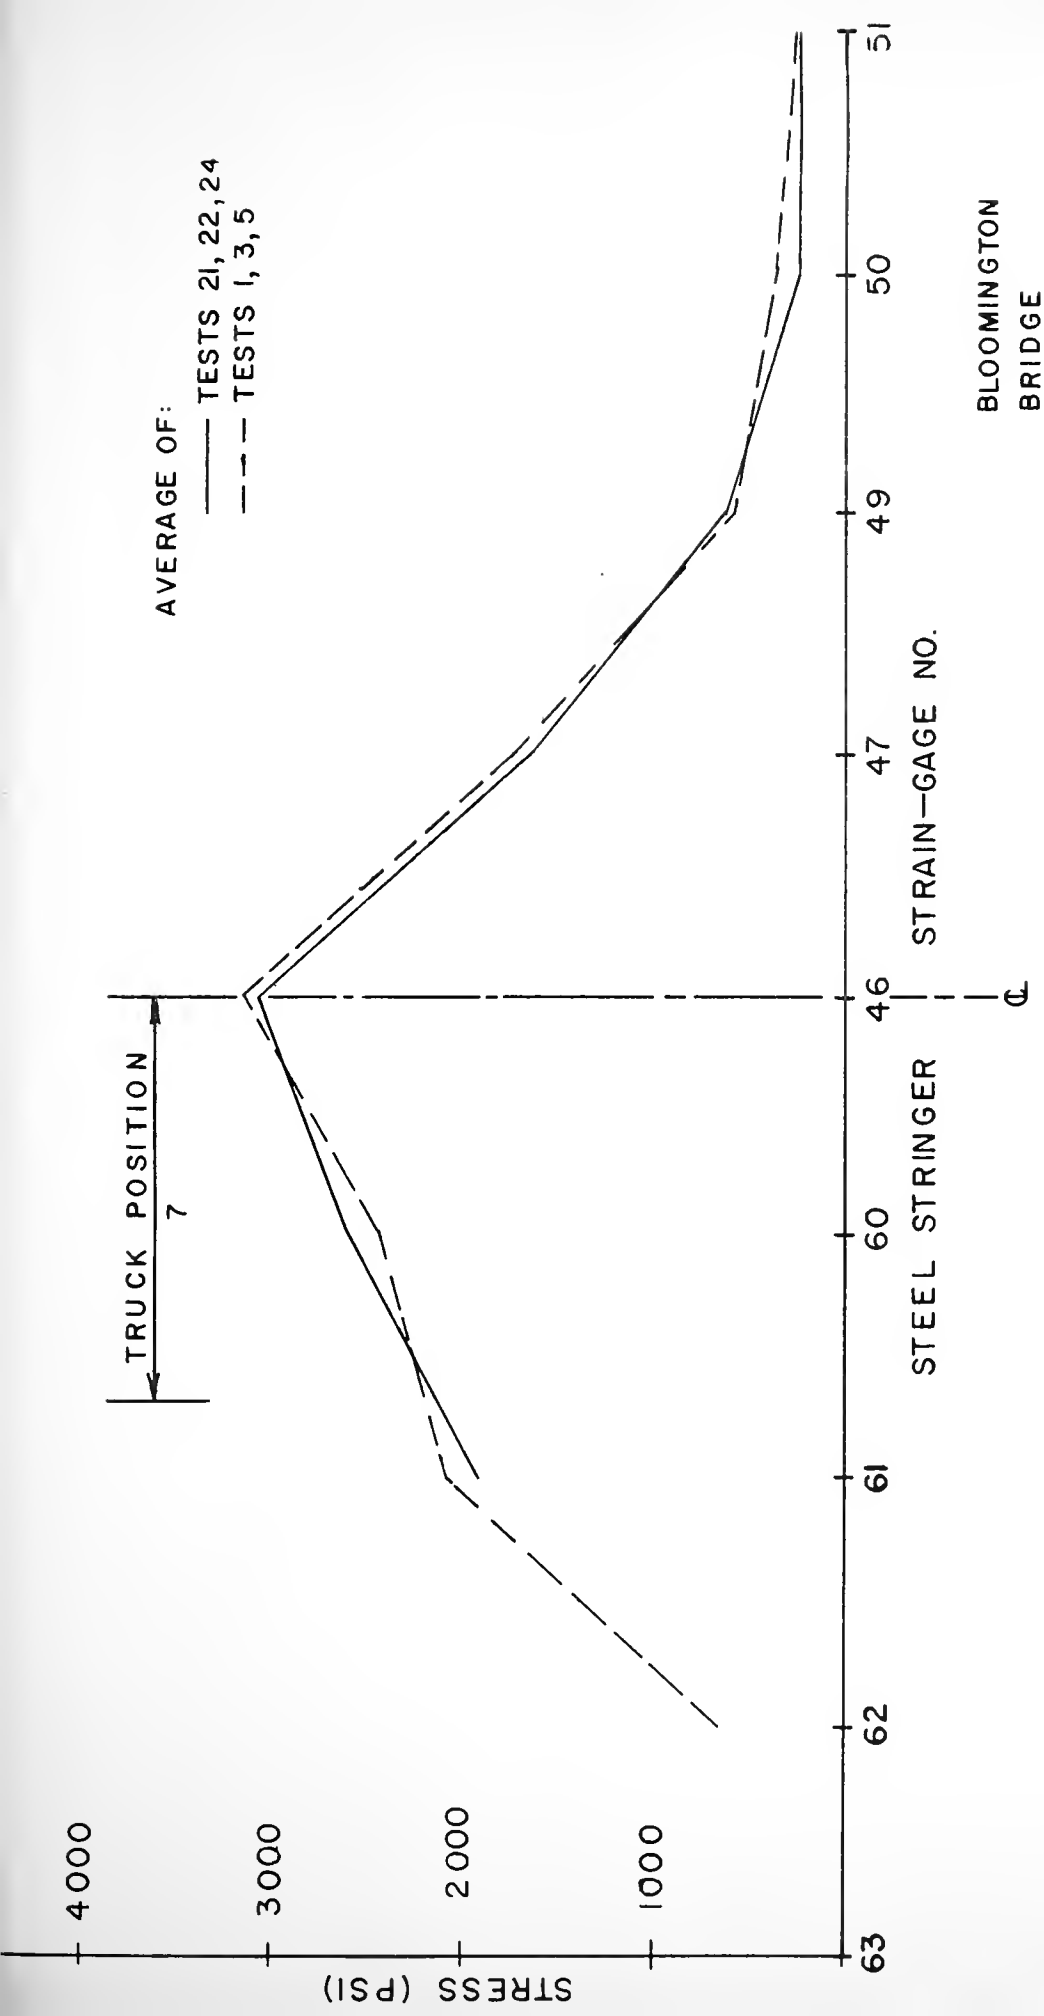
FIGURE NO. 23

TIME EFFECTS ON THE DISTRIBUTION OF
 STRESSES FOR TRUCK POSITION 7 AT SECTION W

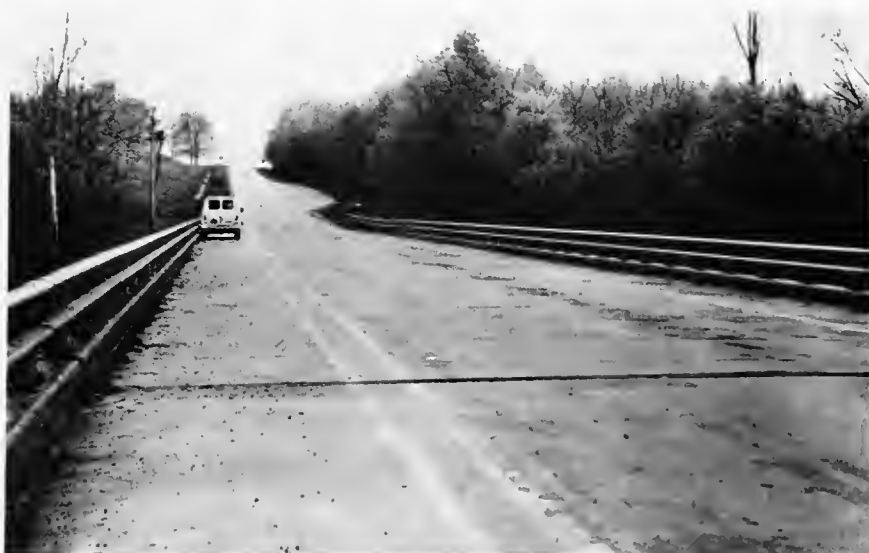
Figure #35. Knightstown Bridge Deck, September, 1974

Figure #35 shows the present (June, 1974) condition of the Knightstown deck. The main problem encountered with the Knightstown Bridge was due to irregularities in the width of the joints at the top of the slab. After the slabs were post-tensioned together, there were numerous locations where the indicated 1/4" clearance at the top of the joints did not exist. Figure #36 is a map of the areas where the joint widths are less than 1/8", and approximately half of the defective joints shown are completely closed. There were no immediate effects except the joints leaked water when it rained due to the fact that no sealant could be installed in the joint. However, a few months after the bridge was opened, the concrete in the vicinity of the closed joints began to spall and this spalling has continued to the present time. In some areas the spall has been large enough to require an asphalt patch. Figure #37 shows a closed joint where a portion of the joint has been progressively failing on the surface of the slab. The underside of this joint appears normal. The cause of the joint irregularities was irregularity in the forms used to cast these slabs. These forms had additional steel strips tack-welded to the tops of the main sideforms in order to form the crown in the section. These tack-welded steel strips warped and caused a bad fit of the slabs in the field. In the future, the sides of the forms used to cast these slabs should be parallel and as straight and stiff as possible.
